## Confidential Inspection Report

LOCATED AT:  
604 Geranium Ave. East  
St.paul, Minnesota 55130

INSPECTED ON:  
Friday, January 20, 2017

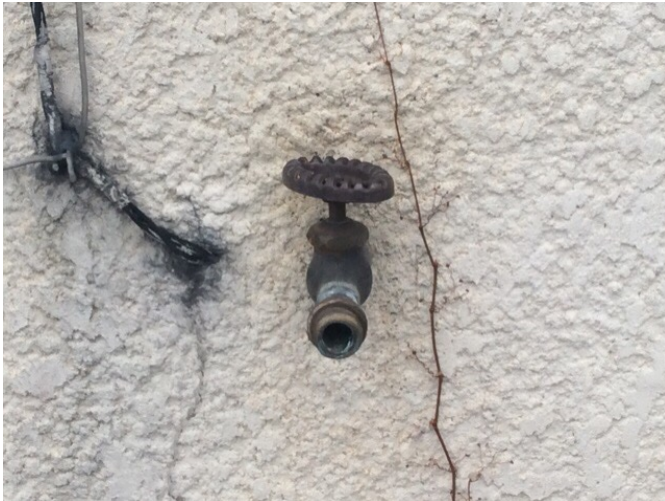
### **EXTERIOR PLUMBING**

Backflow prevention devices are now required on exterior hose bibs to prevent contamination of the domestic water supply. These devices are inexpensive and available at most hardware stores. Upgrading the hose bibs should be considered.

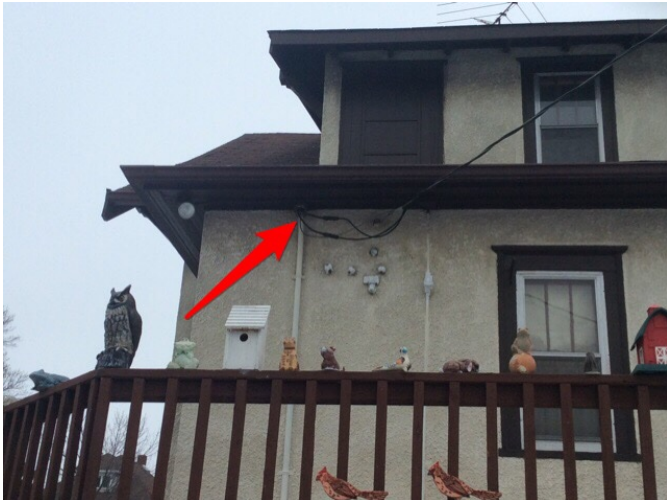
### **SERVICE DROP**

The overhead service conductors are too low over the deck, creating a potentially hazardous situation. We recommend replacement or reconfiguration of the service drop, in accordance with present standards. Excel should be contacted to extend service mast.

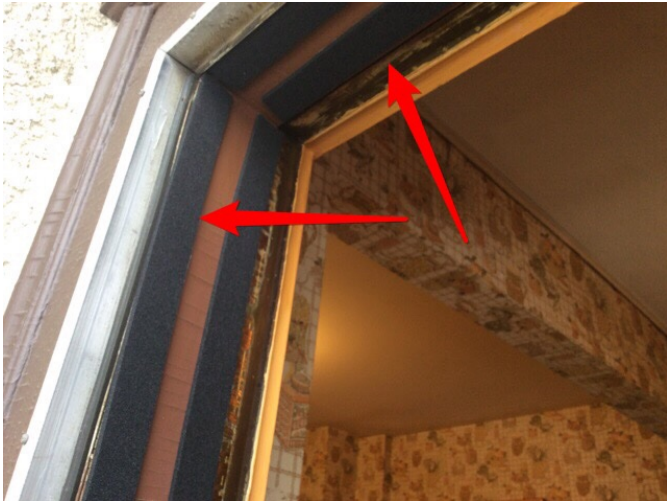
## DOORS

The exterior doors appear to be properly installed and generally in serviceable condition, with exceptions noted below. Exterior doors are older and show signs of wear. Weatherstripping has deteriorated and should be repaired.

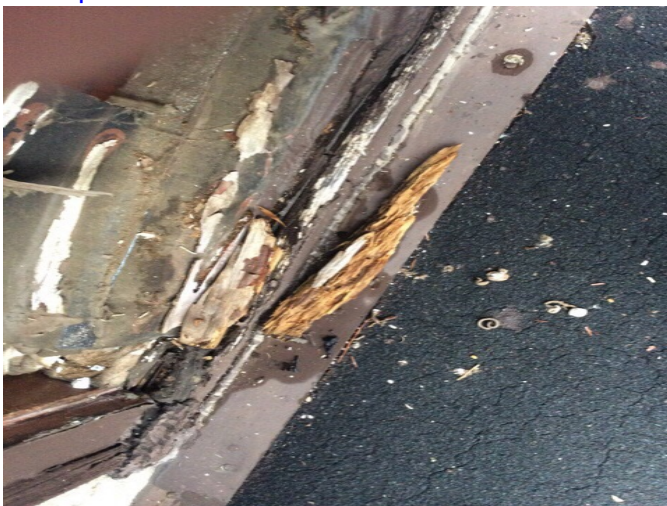
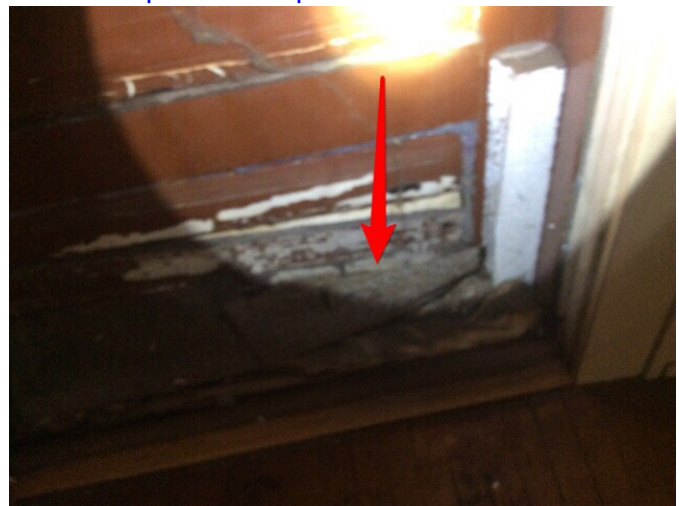
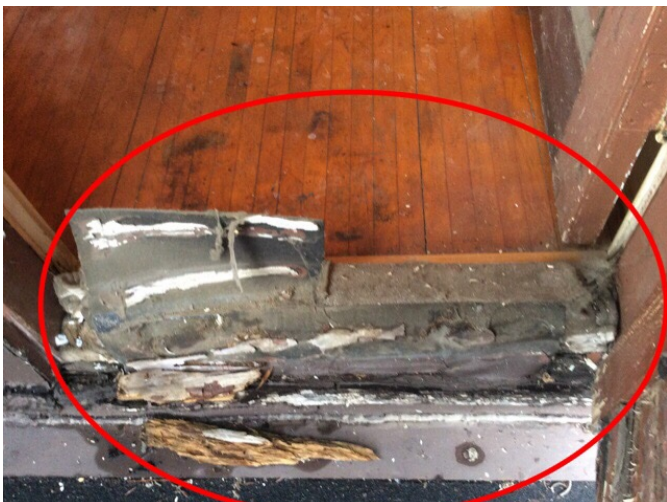
The upstairs exterior door is deteriorated. We recommend it be repaired or replaced.

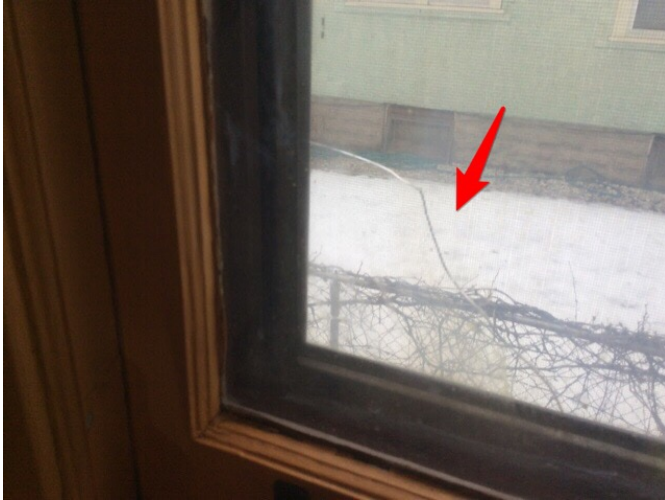
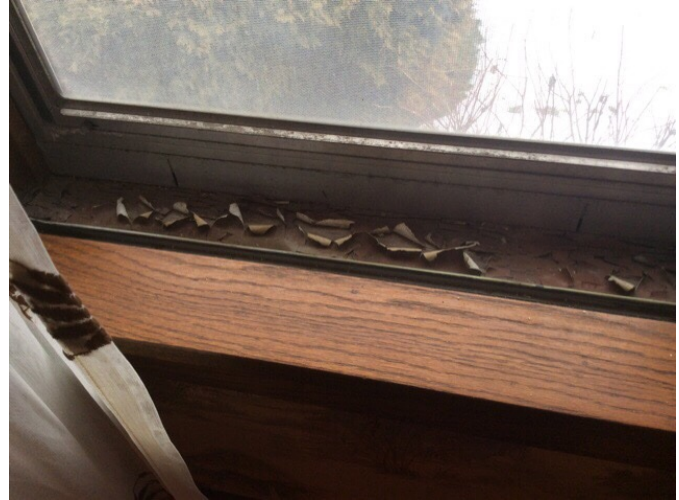
## WINDOWS

Several windows are deteriorated. Several windows are painted shut and several panes are cracked. At some point We recommend they be, repaired and/or replaced.

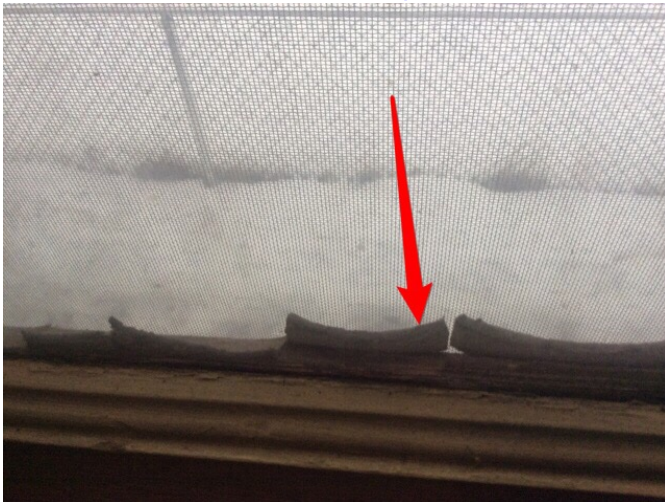
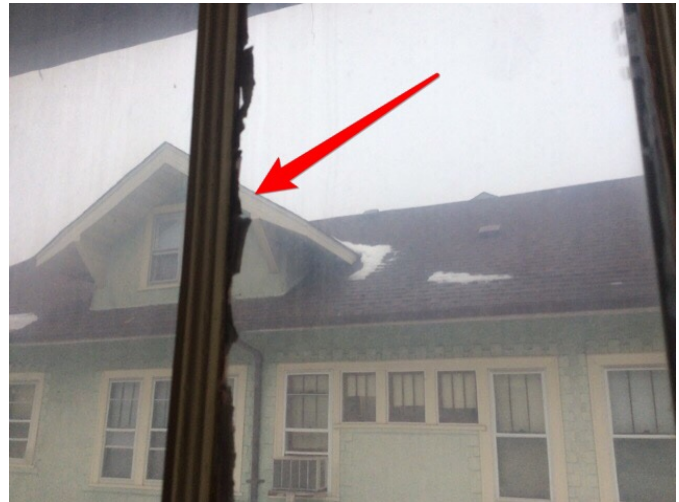
## GLAZING

There is cracked or broken glass at several locations. We recommend that all broken glass be replaced.

The glazing putty is dry and cracked at many of the windows. This condition is not urgent but should be attended to when the house is painted.

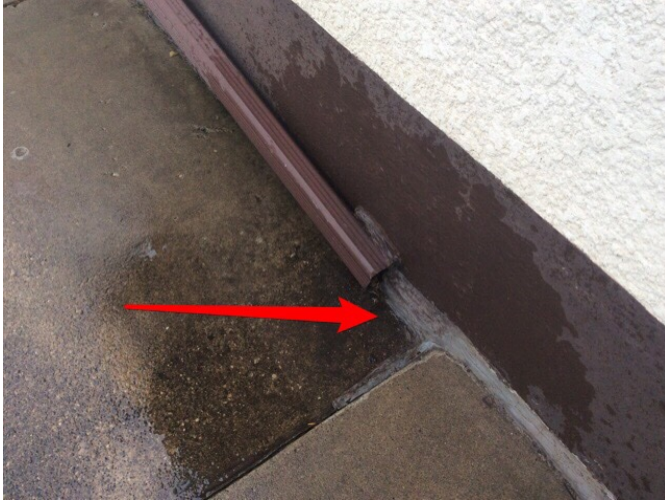
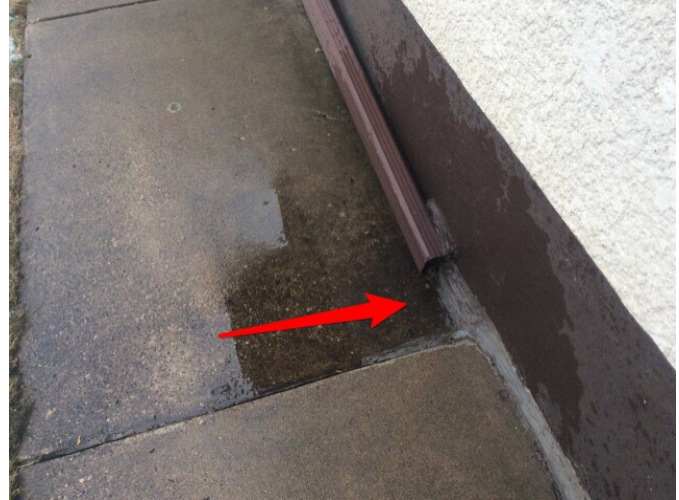
### **DOWNSPOUTS**

The downspouts appear to be properly installed and in serviceable condition, with exceptions noted below. Downspout on right side of home drains next to foundation. This water could leak into basement. Recommend reconfiguring to drain onto lawn.

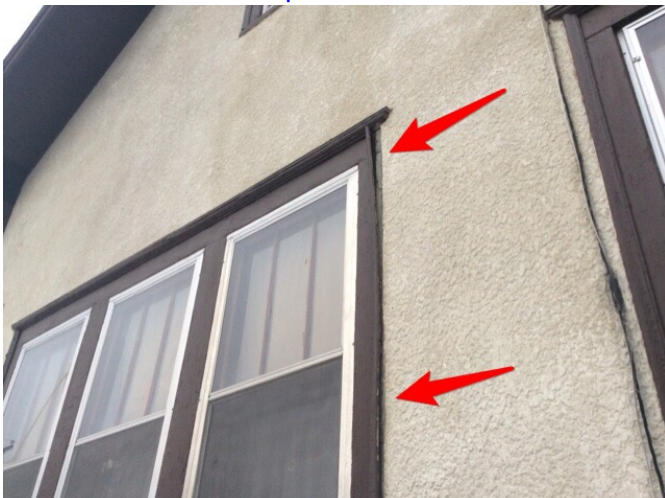
## TRIM

The trim is loose or improperly secured at the right side of house. We recommend it be resecured in accordance with accepted standards.

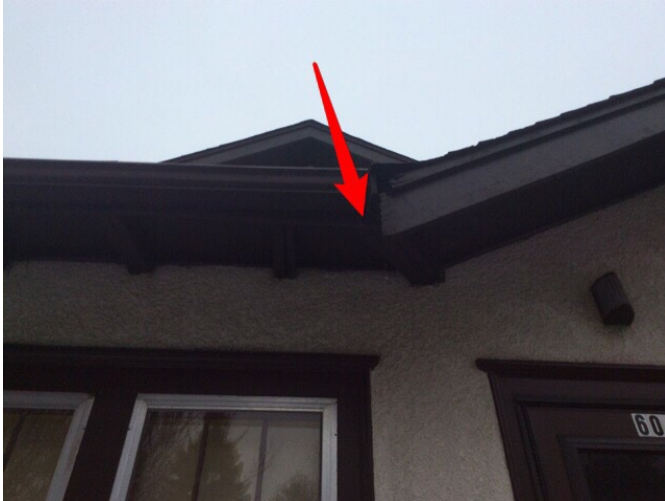
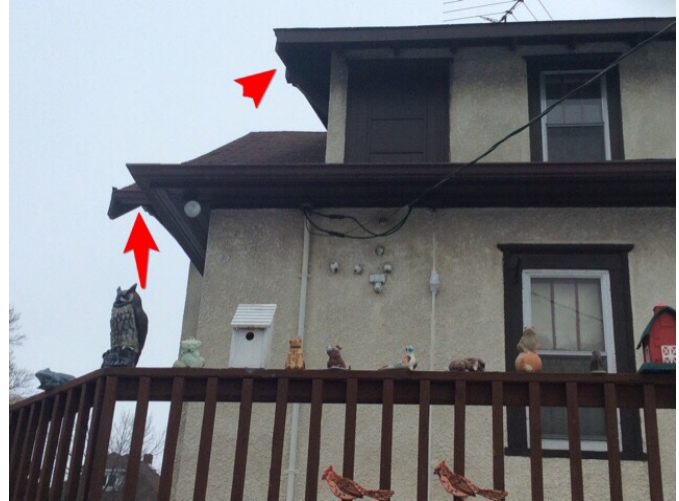
## EAVES/SOFFITS

Sections of the eaves around the house are deteriorated. This is normal for a home this age. No further damage will occur because of this, but recommend repair at some point.

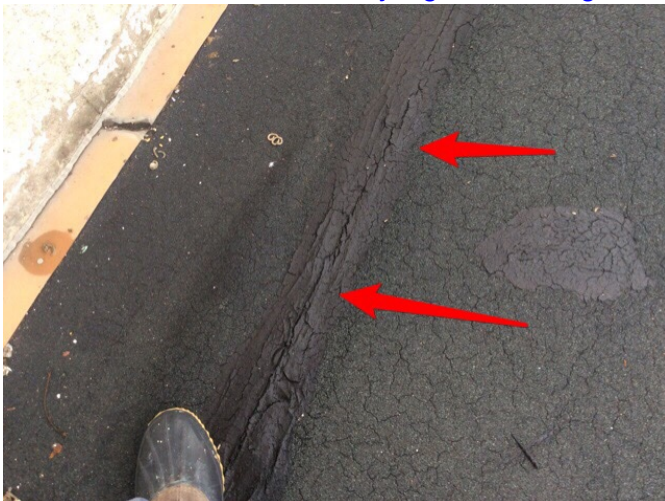
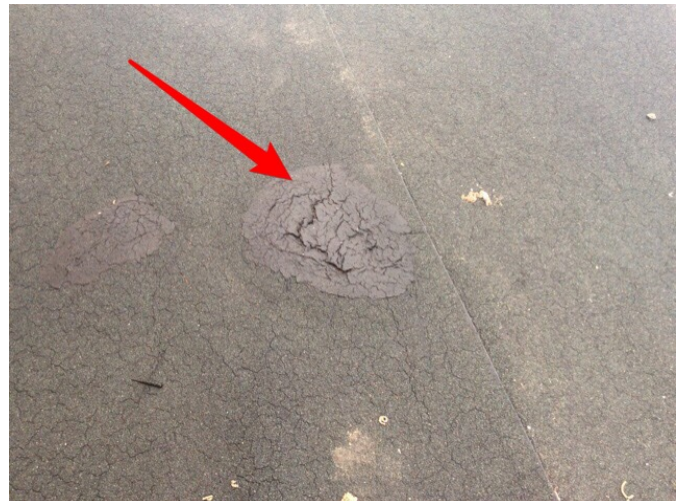
## PATCHING/REPAIRS

The flat roofing surface materials have been patched. It appears that the patching was necessitated by the advanced age of the roof. The need for ongoing maintenance and/or replacement must be anticipated. Monitor above flat roof for any signs of leakage.

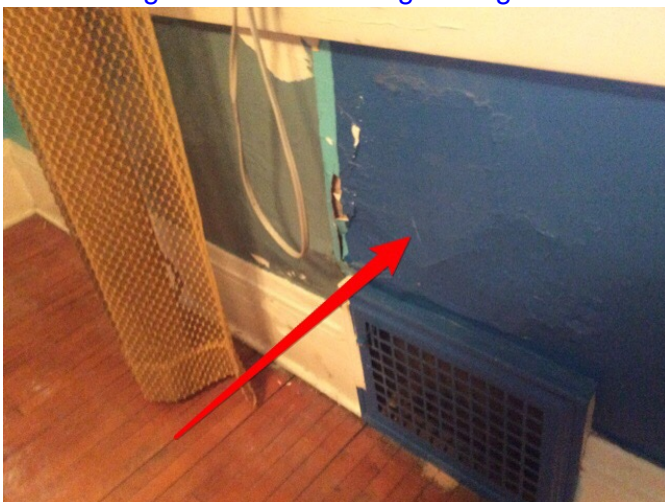
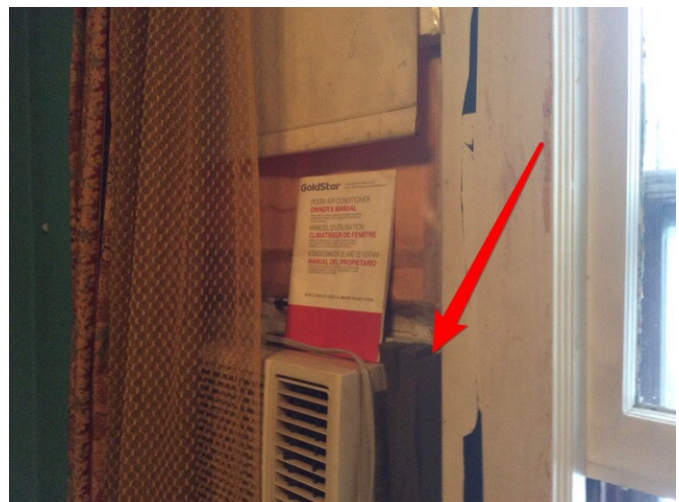
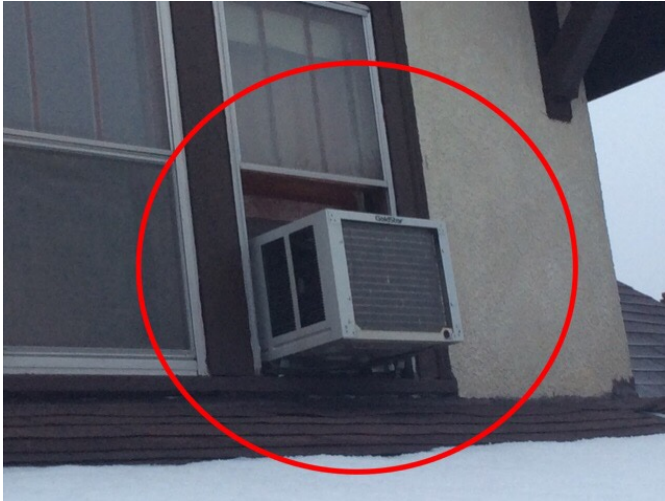
Window air conditioner only. This unit was not installed properly and should be removed. Water and cold air are entering house and causing damage.

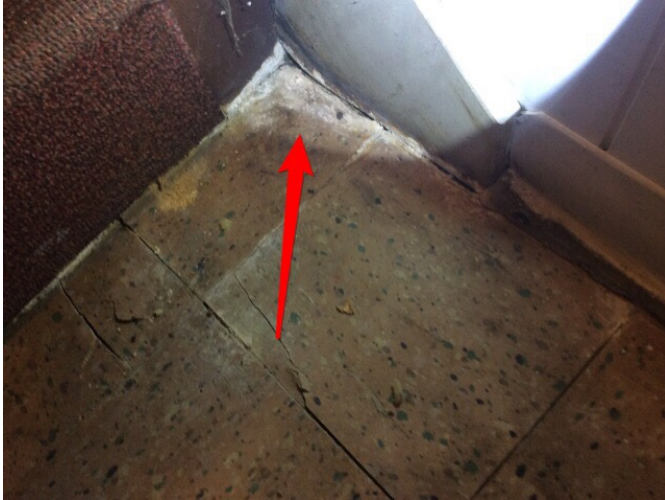
## MOISTURE

The basement was dry at the time of this inspection. However, we direct your attention to the items mentioned below. Signs of moisture at bottom of stairs. I believe this is a direct result of water from outside downspout.

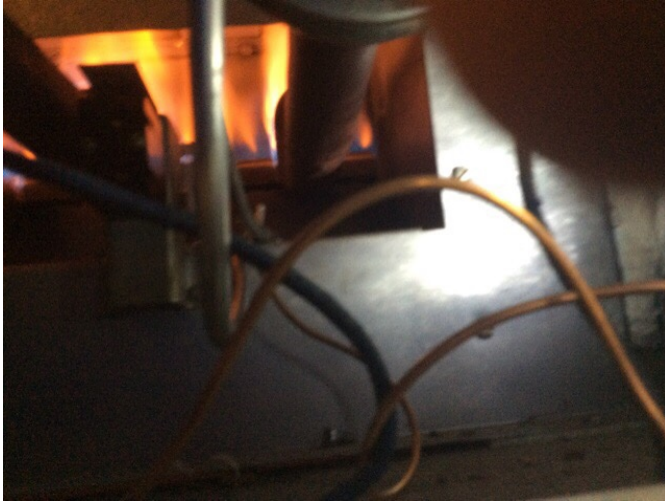
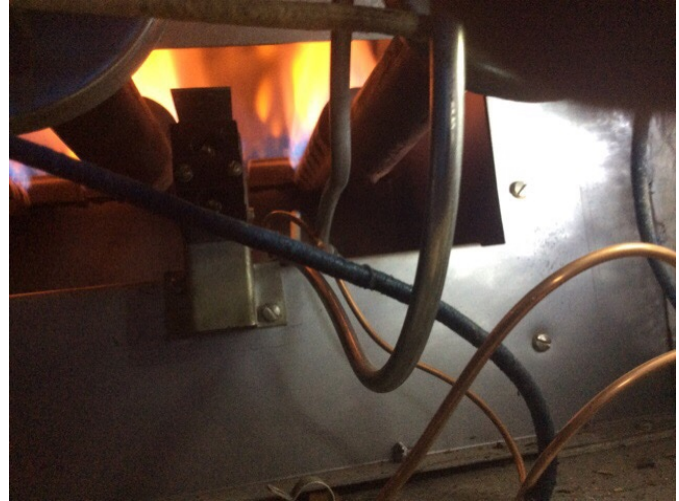
## **BURNERS**

The burner flame is yellow tipped, suggesting too little primary air, clogged burner ports, improperly adjusted burners, or a clogged draft hood. We recommend the furnace be serviced, cleaned and tuned.

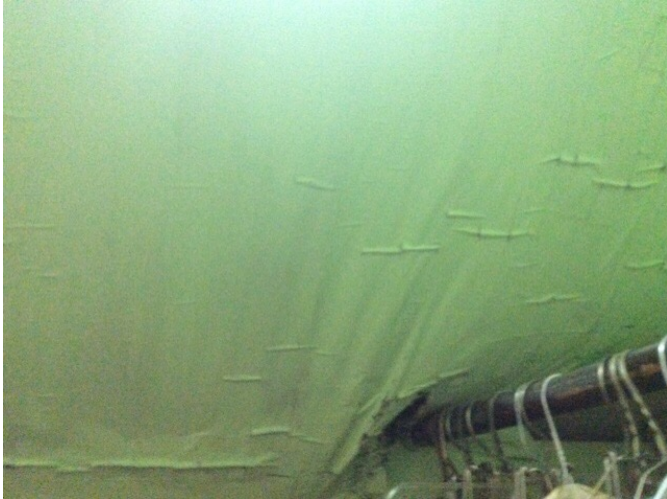
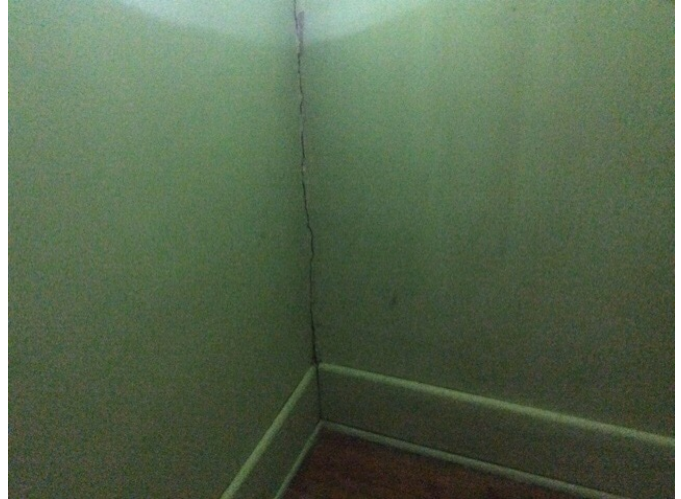
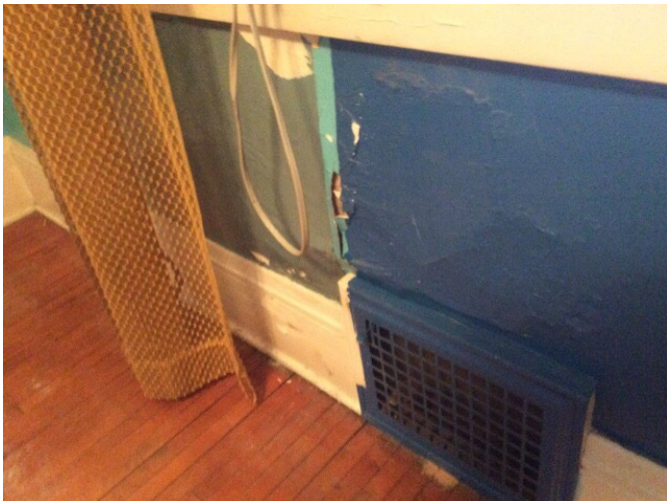
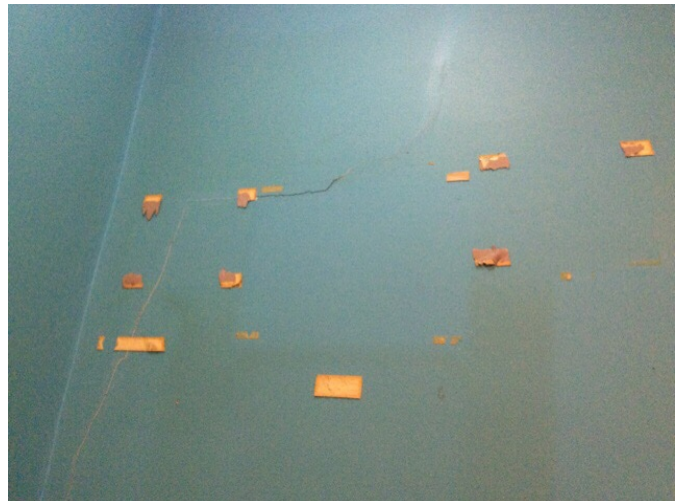
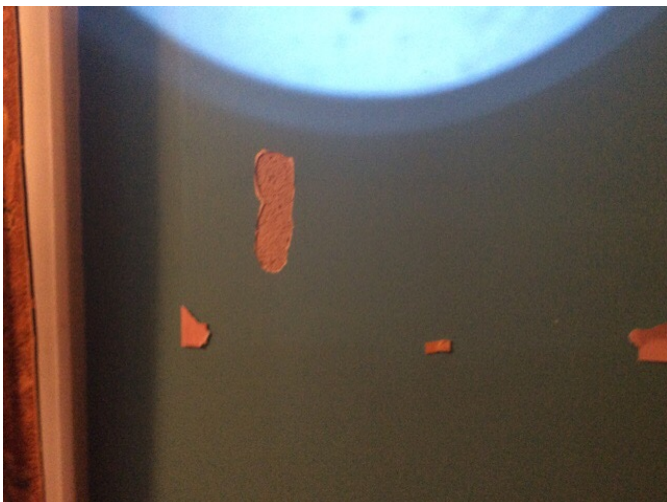
There is wear and tear of the surfaces throughout the building, of the type generally resulting from deferred maintenance. We make no attempt to list all cosmetic flaws, but do suggest attention to items relating to function and safety. Many cracks and areas missing plaster

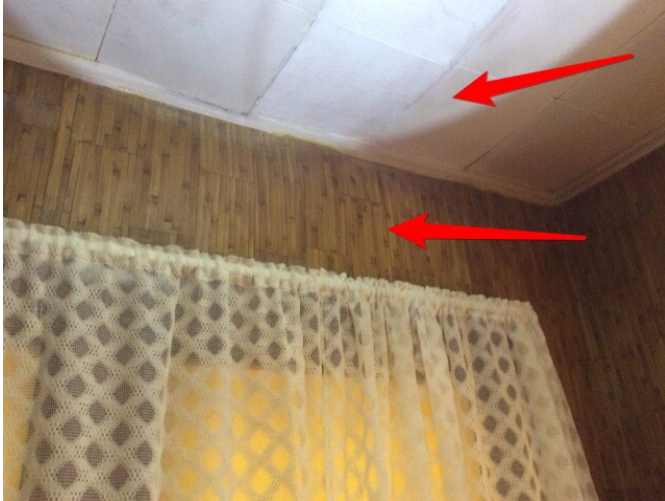
Front porch ceiling and wall show signs of past water damage. I suspect damage was caused by ice dams. Roof should be monitored for ice buildup and snow removed when possible.

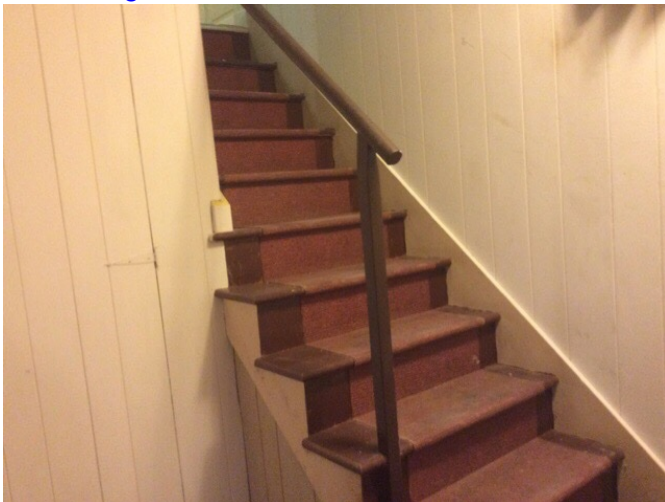
The railings at the basement are loose. We recommend they be repaired or replaced.

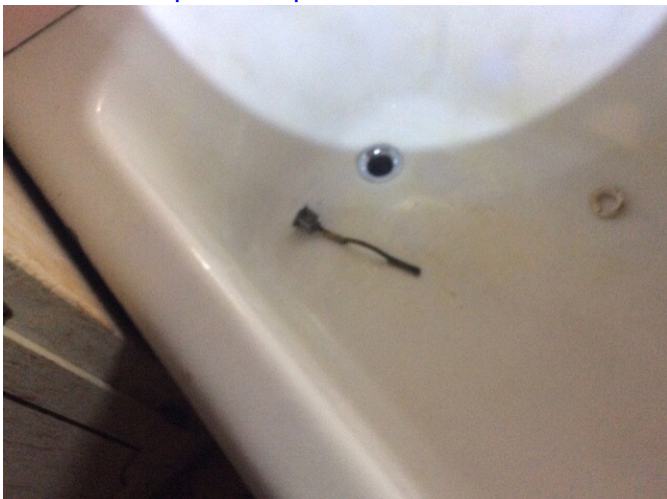
The drain stop is not operational. We recommend it be repaired or replaced.

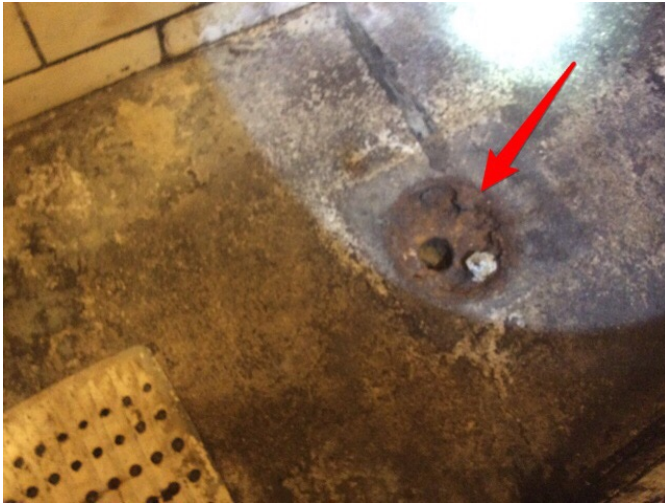
Shower drain in basement is missing cover. A replacement cover can be found at any home improvement store.

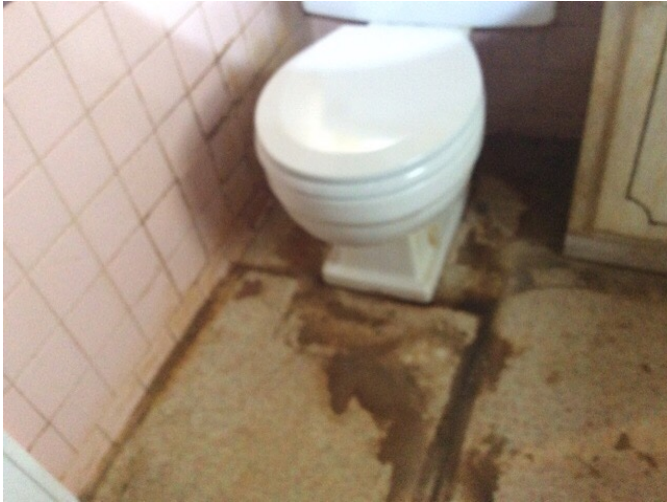
Both bathrooms although functioning, are in need of serious cleaning and repair.

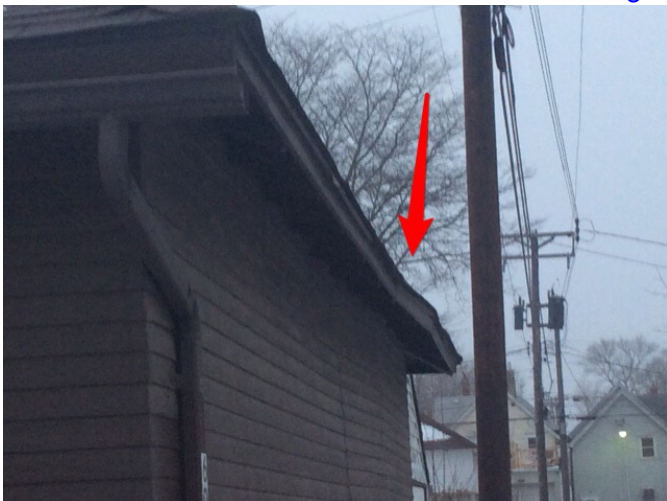
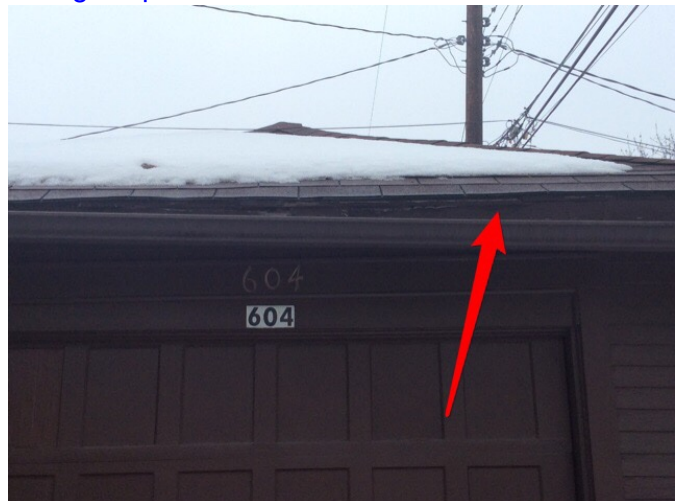
Some of the fascia and soffit on exterior show signs of rotting. Repair as needed.

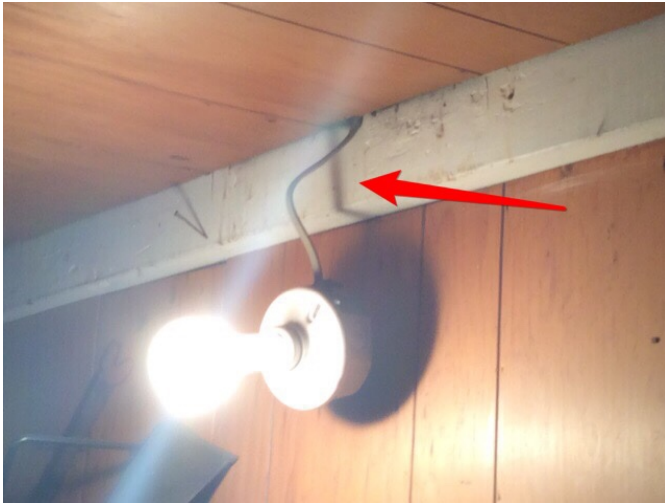
The work room light fixture has been installed in a substandard manner. It is not properly attached to wall. We recommend it be repaired or replaced.

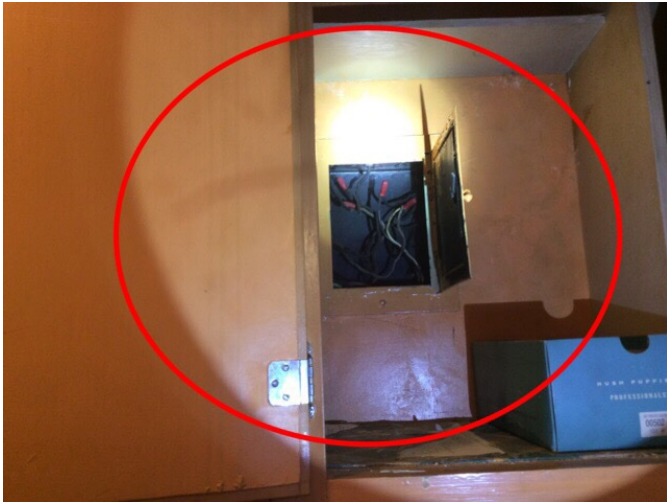
We found exposed wiring in cabinet where the old fuse box was. Even if insulated, we recommend all wiring be encased in a conduit or otherwise protected in accordance with present standards.

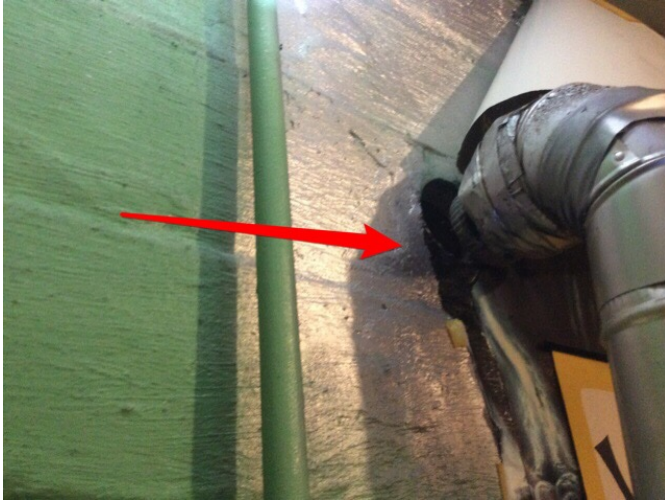
The dryer vent has been disconnected. We recommend it be reconnected to avoid lint and moisture problems in this area.
