## Confidential Inspection Report

LOCATED AT:  
604 Geranium Ave. East  
St.paul, Minnesota 55130

INSPECTED ON:  
Friday, January 20, 2017

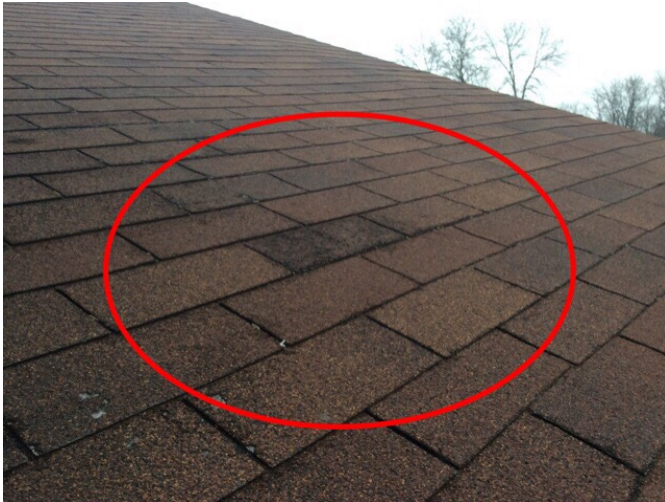
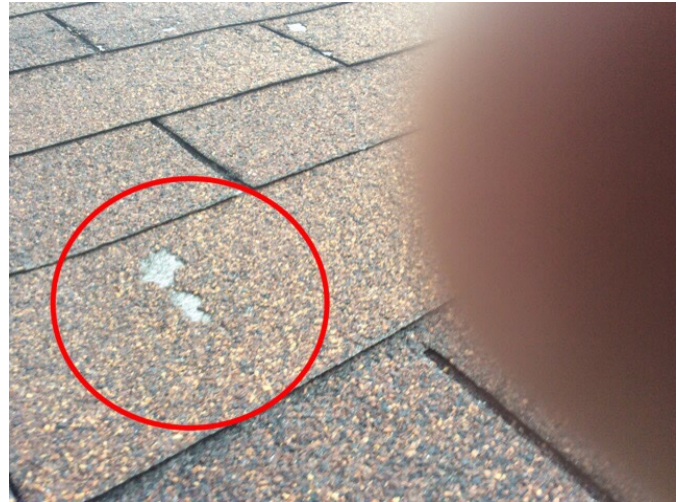
## PATCHING/REPAIRS

The flat roofing surface materials have been patched. It appears that the patching was necessitated by the advanced age of the roof. The need for ongoing maintenance and/or replacement must be anticipated. Monitor above flat roof for any signs of leakage.
